CHAPTER 3: Structural Features of the Fortification and Encampment

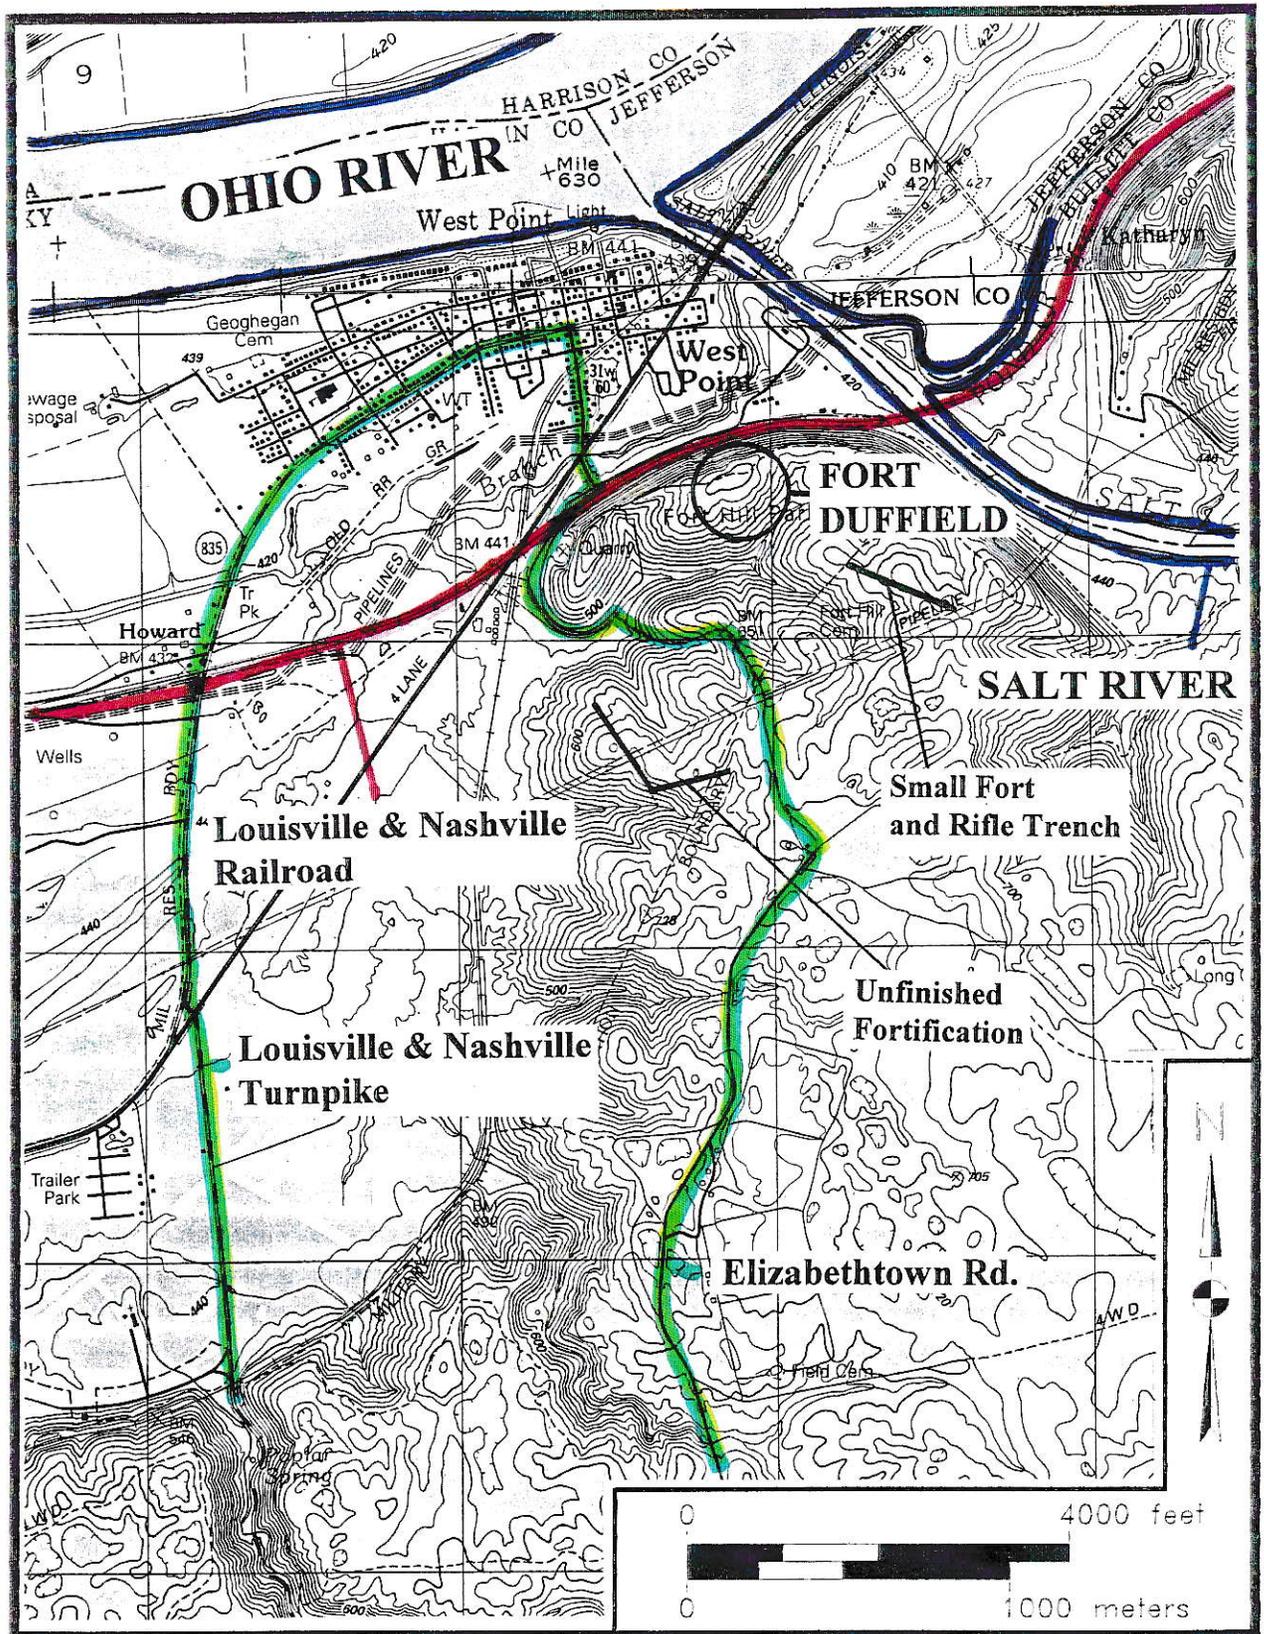
Figure 7. Strategic location of Fort Duffield relative to major transportation routes (U.S.G.S. 7.5-min. quadrangle, Fort Knox, Ky./Ind., 1991; U.S.G.S. 7.5-min. quadrangle, Kosmosdale, Ind./Ky., 1960 [photorevised 1971]).

serve as a deterrent to Confederate advance toward Louisville. Its location on Pearman's Hill gave it a commanding position over major roads, the railroad, and the two rivers that confluenced at West Point (Figure 7). Mahan (1863:xxi) stipulated that field batteries should be positioned with a view to "its suitability for annoying the enemy and...as to its being favorable for limiting the effects of the enemy's fire aimed at the battery." To that end, artillery should "overlook all the ground over which an enemy might advance, the pieces of heaviest calibre being placed on the most commanding points" (Mahan 1863:xxii). Rough ground was preferred because it "breaks the effects of the enemy's ricochet shots, and when it presents bluffs or perpendicular faces towards the enemy it will stop the balls that strike those parts" (Mahan 1863:xxiii).

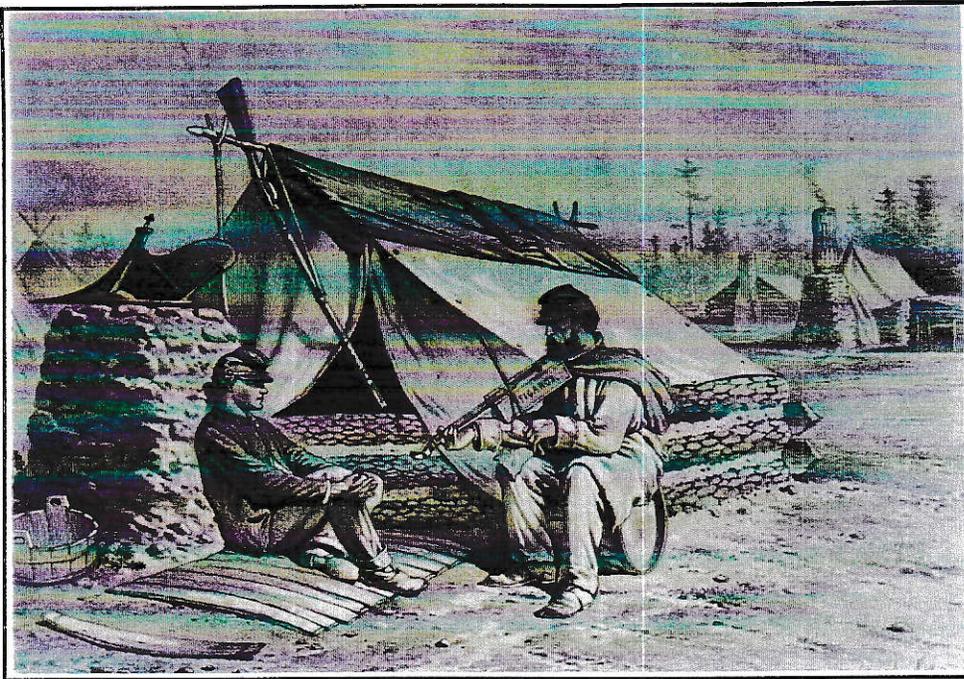
Figure 8. Drawing of a winter hut (Edwin Forbes Collection, LC-USZ62-14188, Library of Congress, Washington, DC).

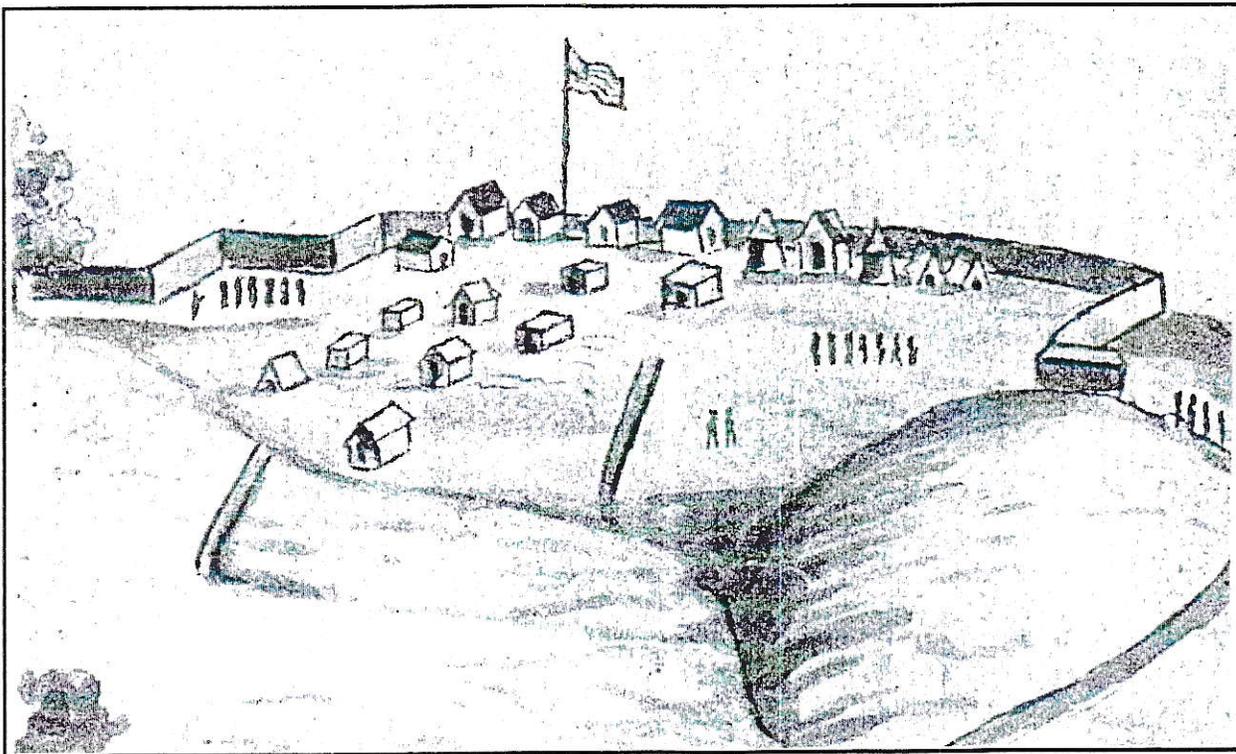
Figure 9. Detail of Charles Kelley's drawing of Fort Duffield showing structures in the fort interior (Richard Briggs, personal collection).

Kelley illustrates a total of nineteen structural components in the enclosure formed by the entrenchment (Figure 9). These appear to include three unreinforced wedge tents, two "bell" or Sibley tents, five flat roofed tents with a square or rectangular floor plan, and nine gable roofed structures that were probably log huts with tent canvas or plank roofing. Five of the gable roofed structures are distinguished by dark roofs that probably were more substantial than canvas. These structures are located nearer to the flag pole flying the American flag in the southeast corner of the fort. The western half of the enclosure is

largely open and clear of tents or other structural features. Another open area is apparent on the east side in the first interior right angle.

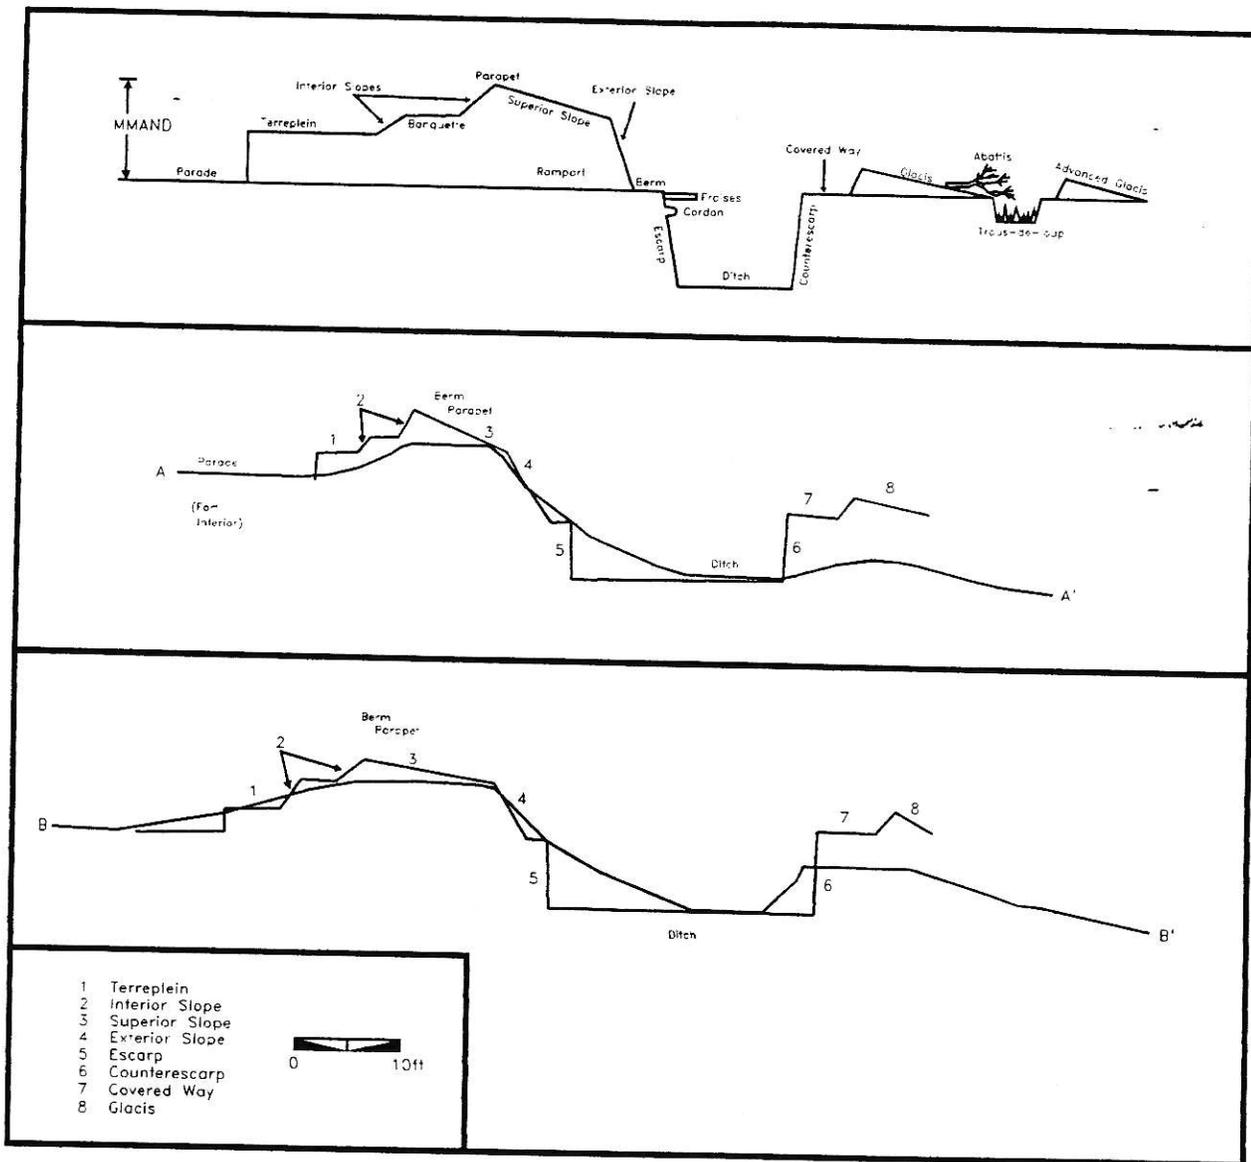
Figure 11. Typical elements of fortification compared to two cross-sections of the main embankment (see Figure 10 to reference these cross-section locations).

The principal manmade feature visible at Fort Duffield is the massive earthen berm that forms the covering mass or embankment, and its component parts, namely, the parapet and the ditch. Capt. Deland described the main trench as "about 1800 feet in length, 12 feet wide and 9 feet deep, 15 feet thick at the bottom and 9 feet thick at the top" (*Jackson American Citizen* November 24, 1861). Its appearance today, while well preserved from an archaeological perspective, obscures the essential features associated with an embankment. Figure 11 illustrates the elements of a typical fortification overlaying two cross-sectional views of the embankment at Fort Duffield. The interior slopes of the parapet were intended to "intercept the enemy's missiles, and to shelter the assailed" (Mahan 1863:18), requiring that the crest of the parapet be at least 6.5 ft. above the parade level. The elevation of the parapet at Fort Duffield is only about 3 to 5 ft. above parade level which may be indicative of some erosion of the berm downslope. The contour of the berm tends to support this conclusion as well. The vertical interior slope of the parapet was usually faced with a revetment made of sod, pisa (earth mixed with clay and water), sand bags, fascines (closely bound twig bundles), hurdles

(vertically set poles interlaced with twigs), gabions (circular wickerwork), or planks. Unfortunately, none of the available documentary evidence indicates what may have composed the revetments. Of the choices available, revetments formed of fascines, wooden planks, gabions, hurdles, or pisa were the easiest and least time consuming to make. The abundance of wood in the Fort Duffield area provided plenty of raw material for revetments; Capt. Deland identified beeches, maple, cucumber, oak, and cherry trees in the vicinity (*Jackson American Citizen*, November 24, 1861). Sand bags could also have been used but they were not particularly durable and would have entailed transporting thousands of pounds of sand from the Ohio River to the top of the hill.

The ditch from which the soil that formed the embankment was derived would have had nearly vertical walls called the scarp and counterscarp. The scarp wall was the side or slope of the ditch adjacent to the parapet and below the berm (see Figure 11). It usually was faced with a timber revetment. Although the scarp wall at Fort Duffield was not excavated, the slope of the ditch suggests that the scarp wall has eroded somewhat. The counterscarp was the slope opposite the scarp on the far side of the ditch from the parapet. Mahan (1863:22) recommended that the ditch be at least 6 ft. in depth, and less than 20 ft. in width. The ditch at Fort Duffield exceeded 6 ft. in depth at the scarp wall but was less than 6 ft. deep at the counterscarp, again possibly due to erosion of the glacis (a natural or manmade slope from the top of the counterscarp which gave the defenders a clear field of fire).

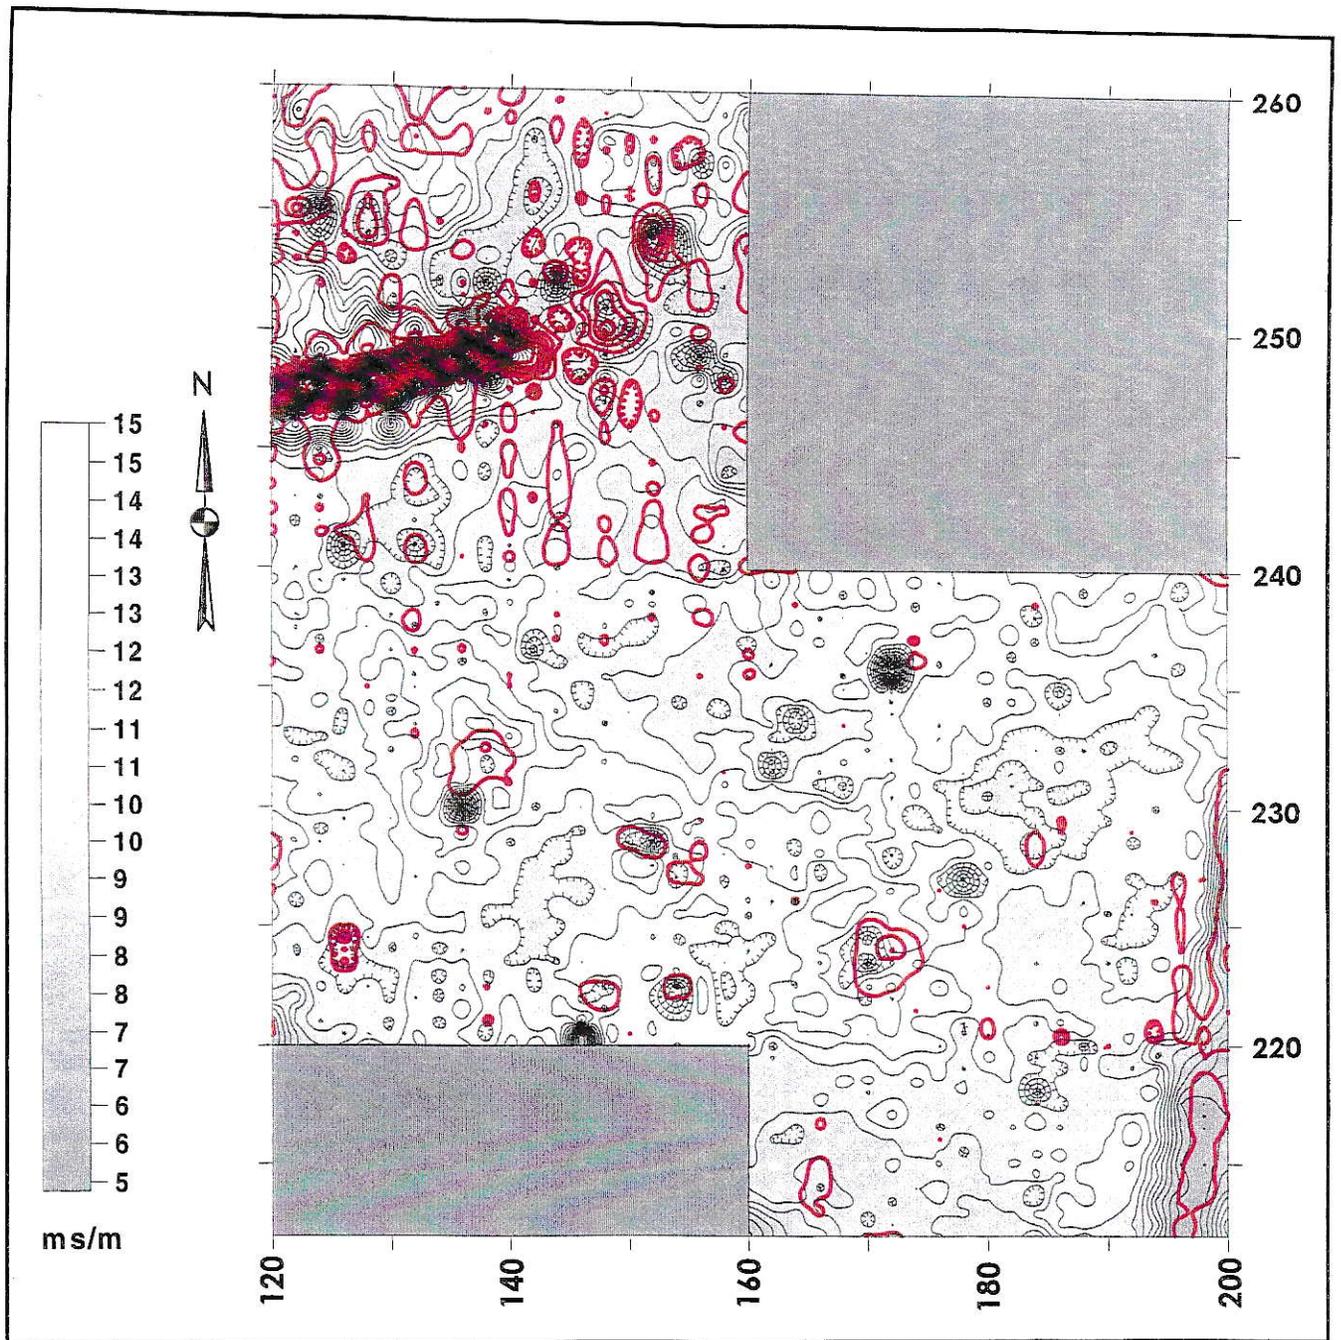
Figure 12. Geophysical survey results (conductivity in gray scale and contours, magnetic susceptibility in red contours).

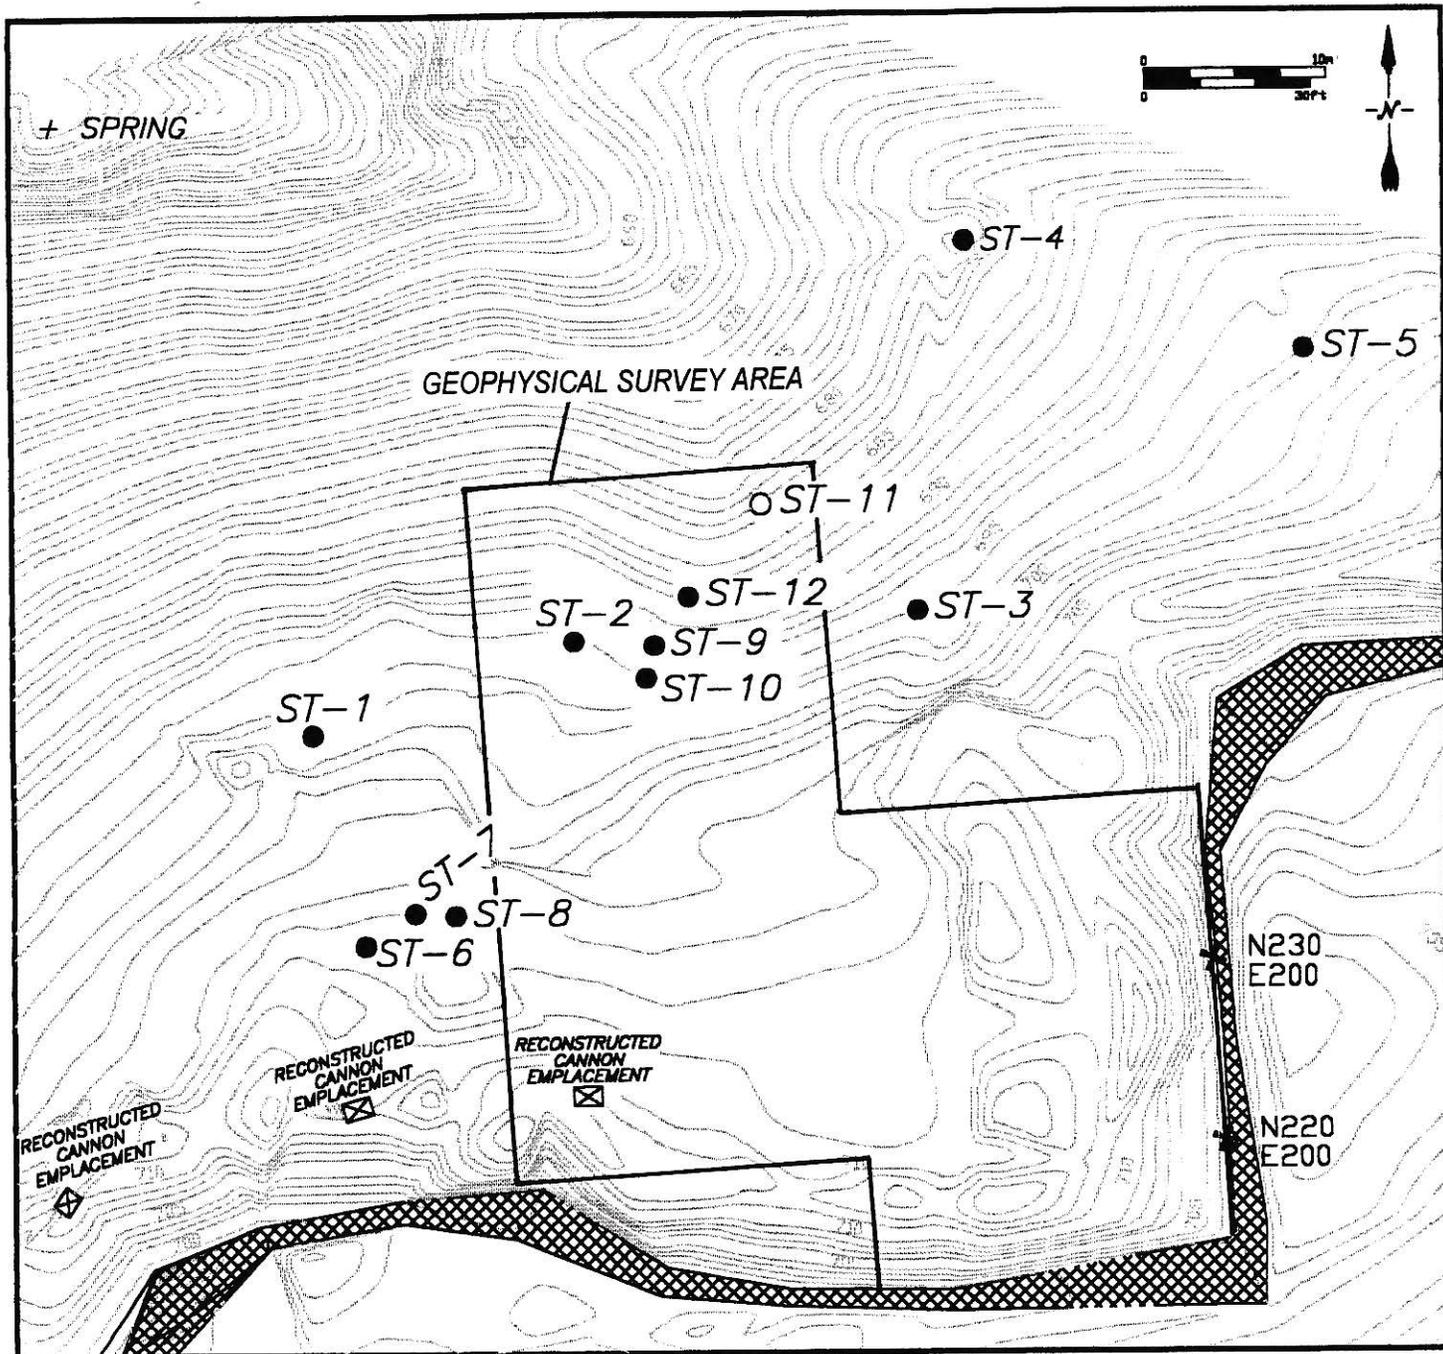
Figure 15. Detail of topographic map showing shovel probe locations.

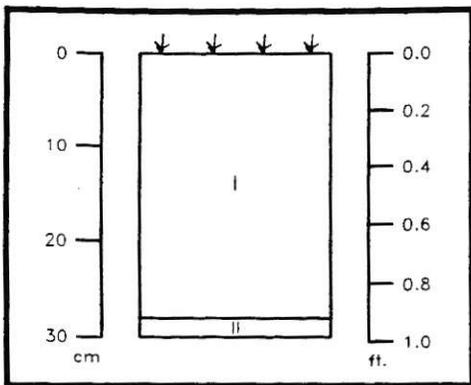
- I - Medium Brown (7.5YR4/3) Loam with Yellowish Brown (10YR5/6)*
- II - Yellowish Brown (10YR6/8) Clay Loam*

Figure 16. Profile of Shovel Probe 2.

Shovel Probe 2 was excavated to a depth of 30 cm. The first 28 cm of soil was characterized by medium brown (7.5YR4/3) loam with yellowish brown (10YR5/6) mottling that became more compact with depth (Figure 16). At 28 cm below surface, the soil became more clayey and was yellowish brown (10YR6/8) in color. Most of the artifacts from this probe date to the twentieth century (see Table 3). One cut nail fragment can be attributed to the Civil War occupation.

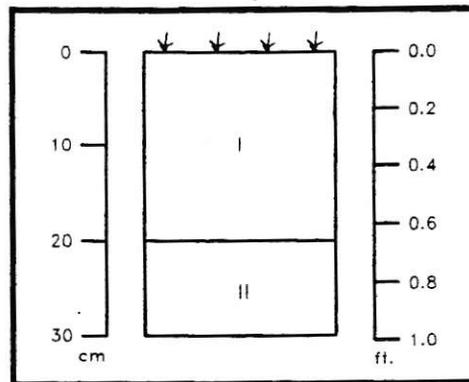
- I - Medium Brown (7.5YR4/3) Silty Loam*
- II - Yellowish Brown (10YR6/8) Clay*

Figure 17. Profile of Shovel Probe 3.

Shovel Probe 3 was excavated to a depth of 30 cm. The first 20 cm of soil was a medium brown (7.5YR4/3) silt loam (Figure 17). At 20 cm below surface, the soil transitioned to a yellowish brown (10YR6/8) clay. Very few artifacts were recovered from this probe; however, two cut nails (one fragmentary; one 5d) were collected that are attributable to the Civil War occupation (see Table 3). Shovel Probe 4 was excavated to a depth of 50 cm. The first 20 cm of soil was a medium brown (7.5YR4/3) silt loam that gave way to a dark yellowish brown (10YR4/6) silt loam

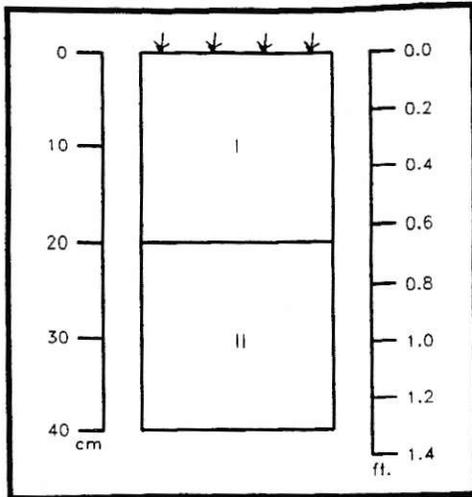
- I - Medium Brown (7.5YR4/3) Silt Loam*
- II - Dark Yellowish Brown (10YR4/6) Silty Loam*

Figure 18. Profile of Shovel Probe 4.

containing many tree roots and continued to the depth of the probe (Figure 18). Although only four artifacts were recovered, all of them were cut nails, including single examples of 8d and 12d cut nails (see Table 3). Shovel Probe 5 was excavated to a depth of 20 cm. The first 10 cm was characterized by a medium brown (7.5YR4/3) silt

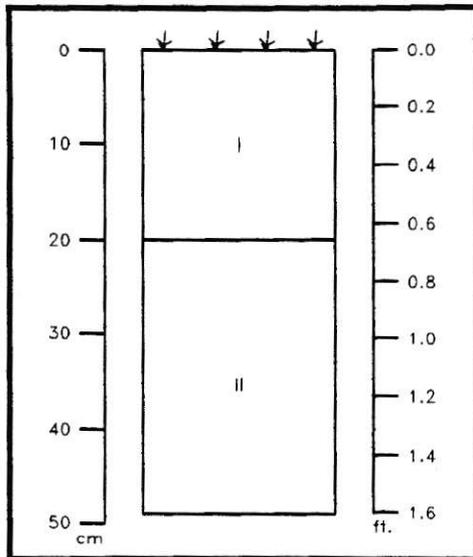
- I - Medium Brown (7.5YR4/3) Silty Loam*
- II - Yellowish Brown (10YR6/8) Compact Clay*

Figure 19. Profile of Shovel Probe 5.

loam (Figure 19). Below this lay a yellowish brown (10YR6/8) compact clay. Only a single cut nail fragment was recovered from this probe (see Table 3). This probe was placed in an area which appeared to have once been an old road.

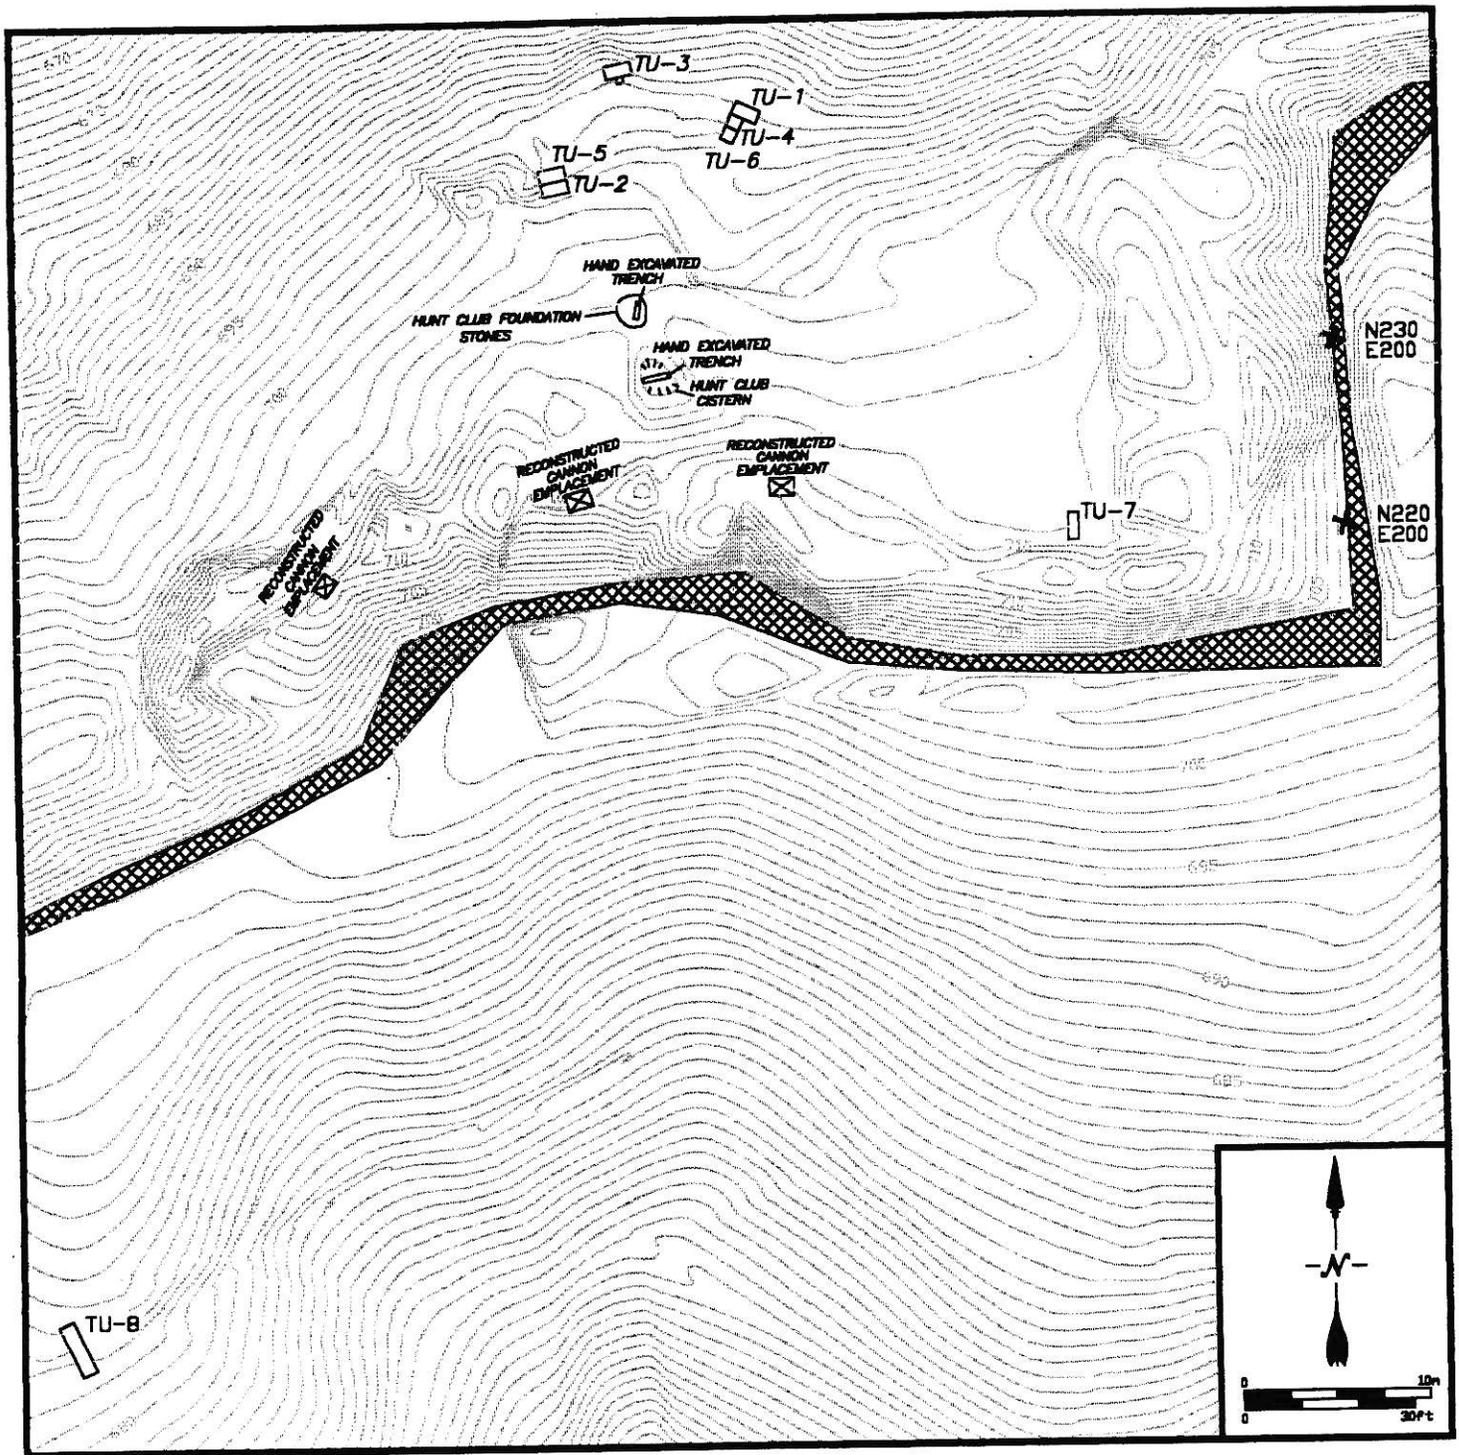
Figure 22. Detail of topographic map showing test unit locations.

Archaeological excavation units (Test Units 1-8) were placed in three areas: on the lower north slope, adjacent to and inside of the main berm, and across the possible rifle trench on the south slope outside the embankment (Figure 22). This section describes the results of these excavations including a description of stratigraphy and artifacts recovered from each unit. The area enclosed by the main entrenchment consisted of a relatively flat piece of ground that runs from the berm approximately 80 ft. (measuring from the midpoint of the entrenchment line) north, where a topographic break gives way to much steeper, down sloping ground. Figure 23 shows an

The loose texture of the upper zone in Test Unit 1 is indicative of secondary deposition by downslope erosion, and the mixed temporal characteristics of the recovered artifacts tend to support the conclusion that soil from higher elevations has eroded downslope. However, the profile of the south wall exhibited an area of grey mottling in the center at the transition between the upper and lower zone. Sticking out of the wall was a metal rod that was initially thought to be a ramrod for a muzzleloading rifle. Test Unit 4, (another 1-x-1 m unit), was opened to uncover this artifact and further investigate the area upslope of Test Unit 1 (see Figure 22).

Test Unit 6, measuring 1 x 1 m, was opened to the south of Unit 4 to determine if buried chimney foundations occurred in the steeper part of the bank (see Figure 22). The first level was identical to that of Test Unit 4, colluviated soil from further upslope. Since an artifact sample of this disturbed zone had already been recovered from the other two units and time for excavation was running short, Level 1 of Test

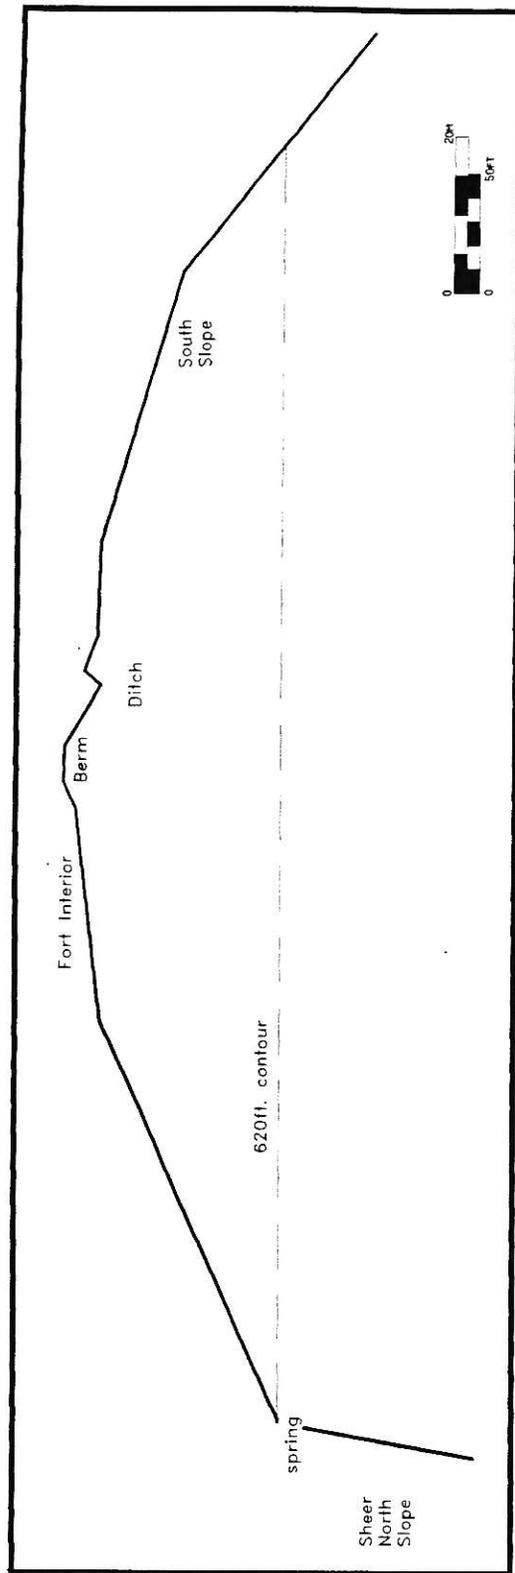
Figure 23. Generalized cross-section of the fort site topography.

elevational cross section of the interior of the fort. The topographic break is characterized by a rapid decrease in elevation over a short distance of approximately ten feet, then a fairly narrow flat bench of approximately twenty feet, and finally a steep downward descent to the edge of the cliff. Area 1, the narrow bench of flat ground, appeared to be a good candidate for some of the tent huts that were built inside the fort. In fact, several reproduction huts have been placed in this area. The flat bench may have been partly natural and partly modified by the soldiers to create an area suitable for their tents or huts, since flat ground within the fortifications was limited and some of it had to be left open for a parade ground.

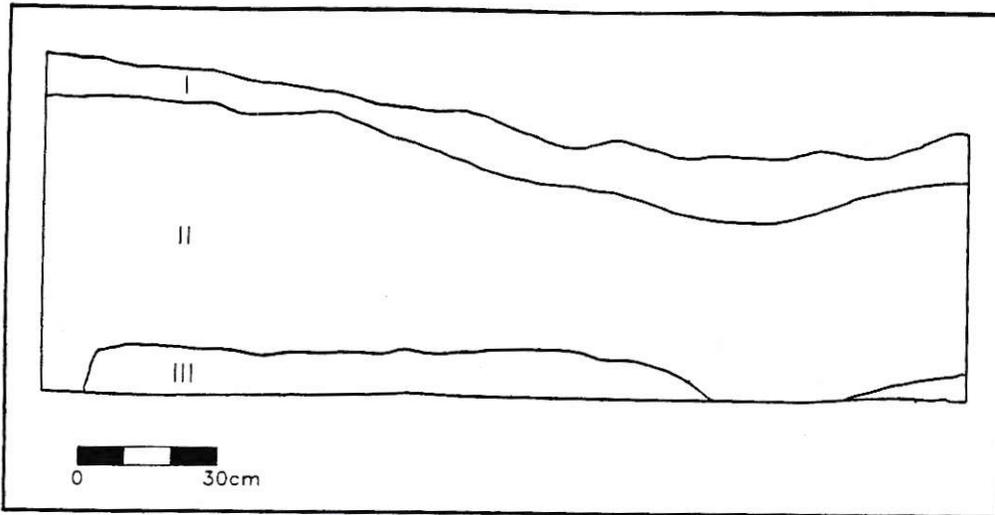
- I - Colluviated Dark Brown (7.5YR3/2) Silty Loam*
- II - Dark Yellowish Brown (10YR5/6) Mottled Silt Loam*
- III - Yellowish Brown (10YR6/8) Silty Clay*

Figure 25. Profile of Test Unit 2 (south wall).

were also recovered. Since artifact density declined and no features were encountered, this unit was closed. A profile of the south wall revealed three zones, including a colluviated, loose silt loam topsoil, a fairly thick midden with much admixture of Civil War era and later artifacts, and a silty clay sterile subsoil (Figure 25).

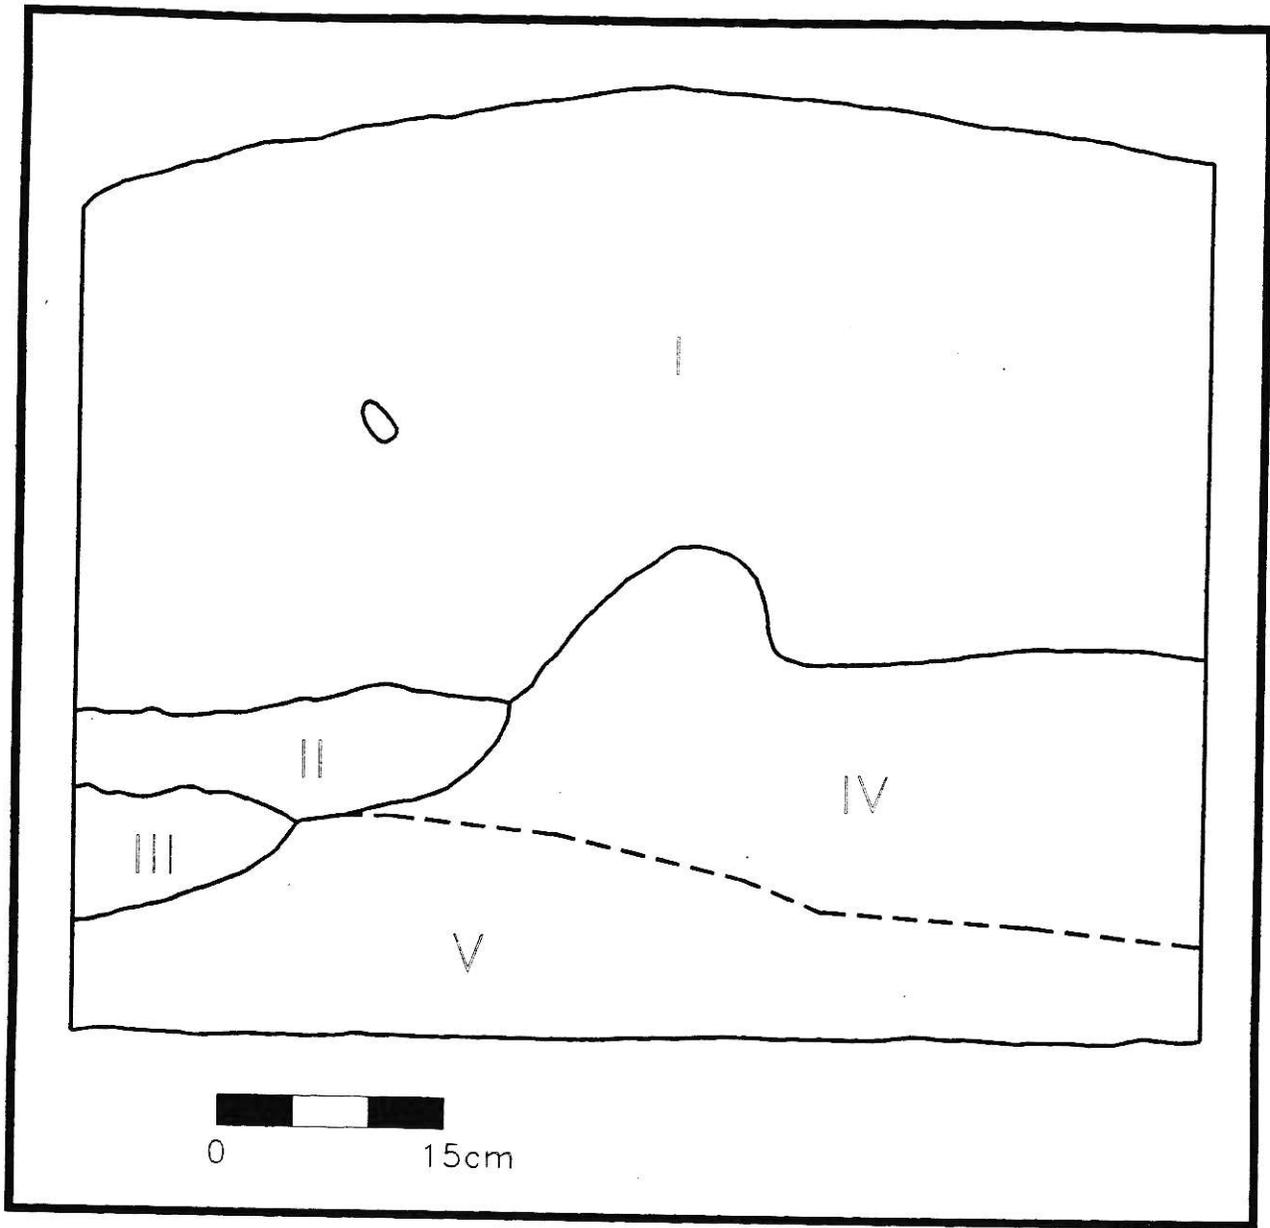
- I - Light Brown (10YR7/3) Clay/Silt*
- II - Yellow (2.5Y8/4) Clay/Silt*
- III - Grey (2.5Y7/2) Clay*
- IV - Yellow Brown (10YR5/6) Mottled Clay/Silt*
- V - Grey/Brown (2.5Y6/2) Mottled Clay/Silt*

Figure 28. South profile of Test Unit 7, main entrenchment berm.

profile, indicative of the loads of earth that were shoveled out of the exterior ditch to form the berm (Figures 28 and 29). A light brown (10YR7/3) clayey silt constituted the bulk of the fill that formed the berm. Beneath this zone were lenses of mottled yellow and gray (2.5Y8/4; 2.5Y7/2), yellowish brown (10YR5/6), and grayish brown

(2.5Y6/2) silty clay. The profile of the west wall of the trench indicated that the upper zone of light brown (10YR7/3) clayey silt probably had eroded downslope after the fortifications were abandoned and the revetments deteriorated (see Figure 29). This zone covered a yellowish brown (10YR5/6) mottled silty clay. Unfortunately, no evidence was

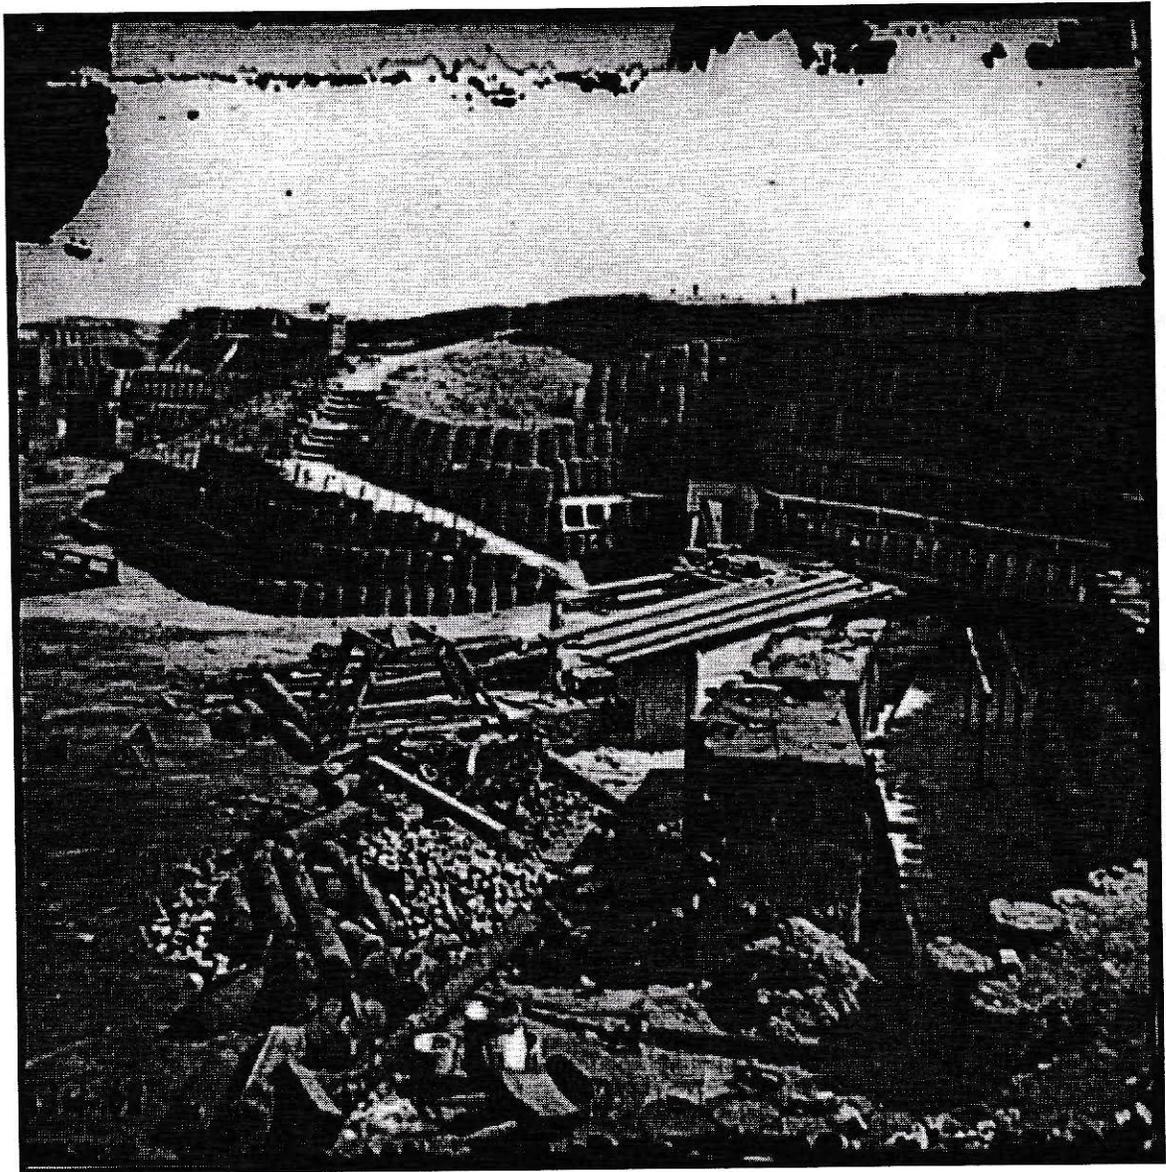
Figure 30. Interior of Fort Sumter, Charleston, South Carolina, with Gabion reinforcement, 1865 (LC-B811-3460, Library of Congress, Washington, DC).

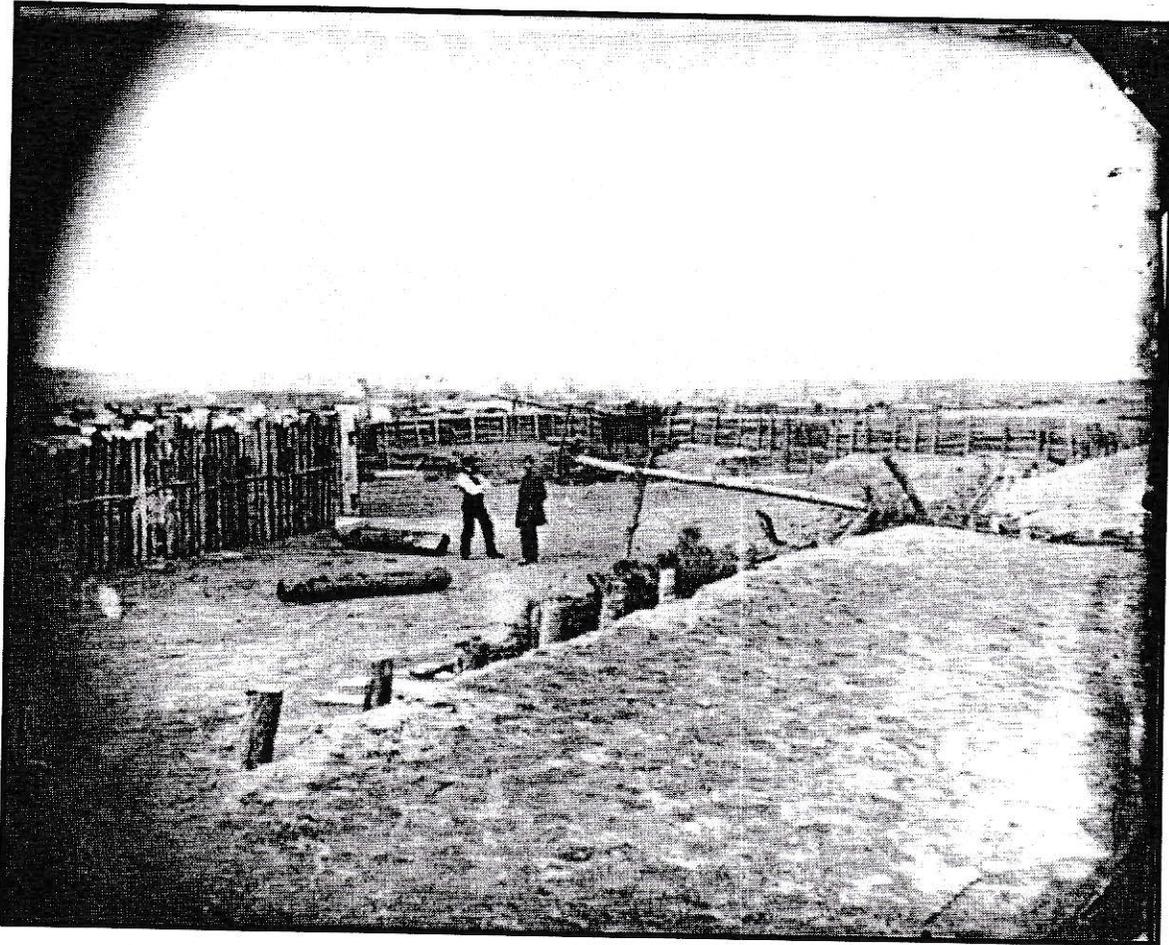
Figure 31. Revetments at Centreville, Virginia, March 1862 (George N. Barnard, photographer, LC-B815-0333, Library of Congress, Washington, DC).

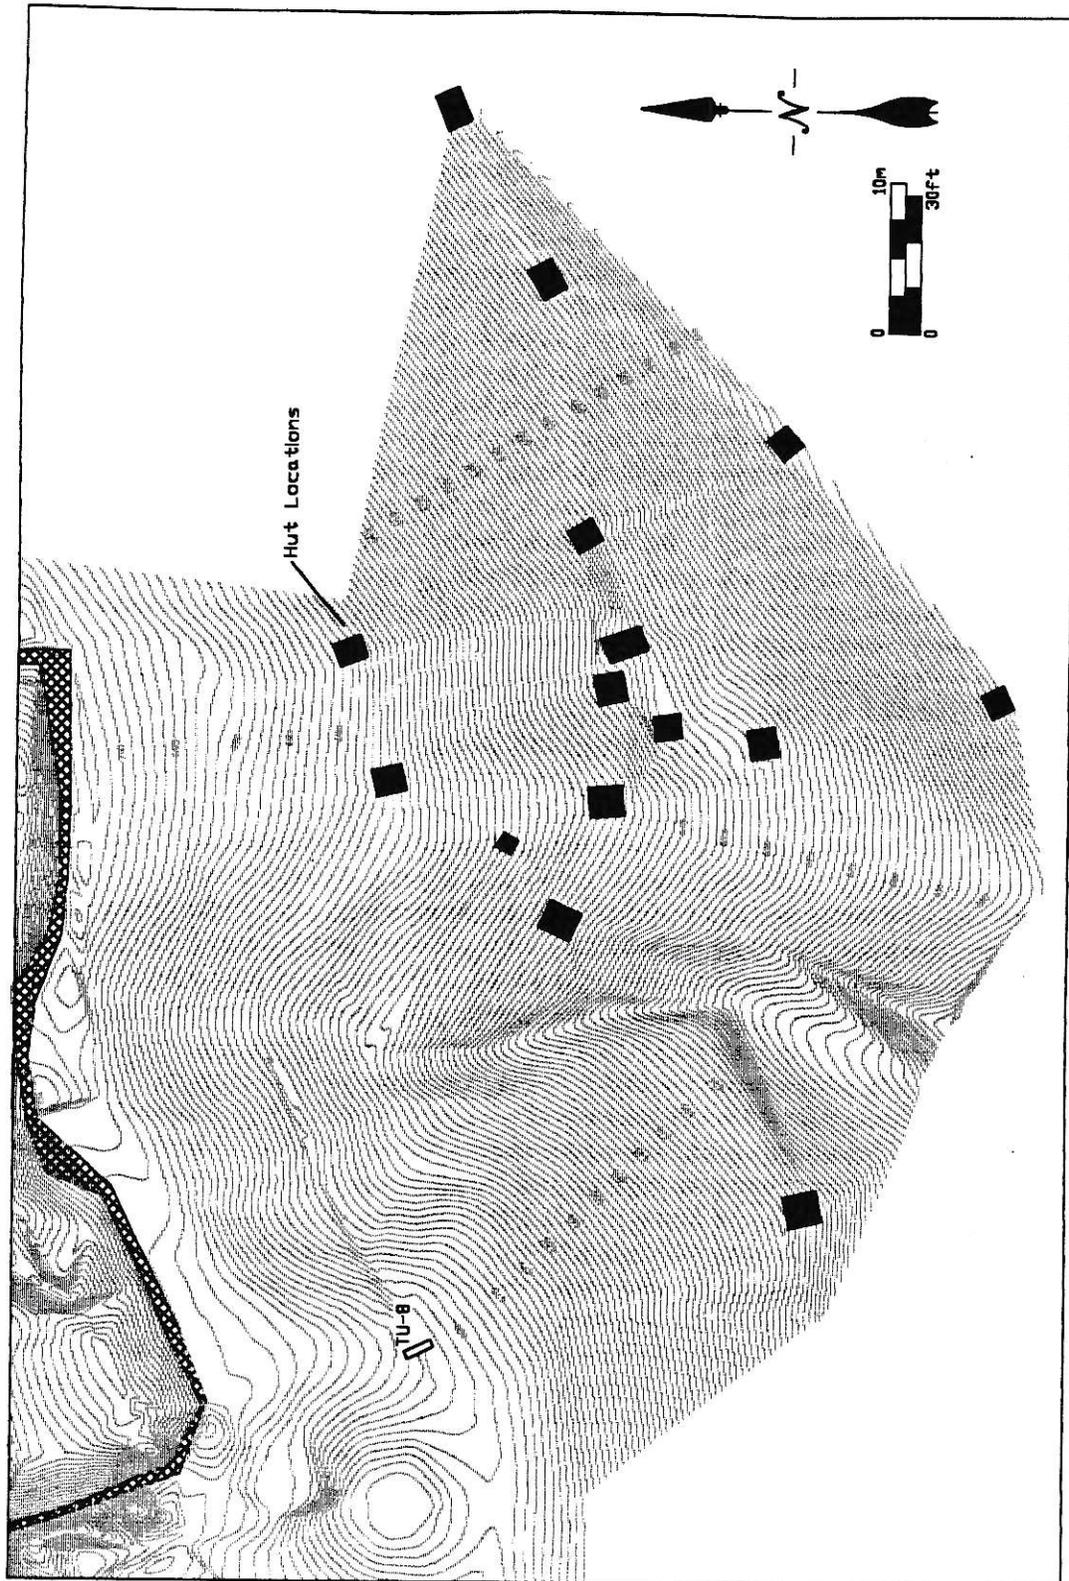
Figure 33. Detail of topographic map showing possible soldiers' hut locations.
