CHAPTER 3: Structural Features of the Fortification and Encampment

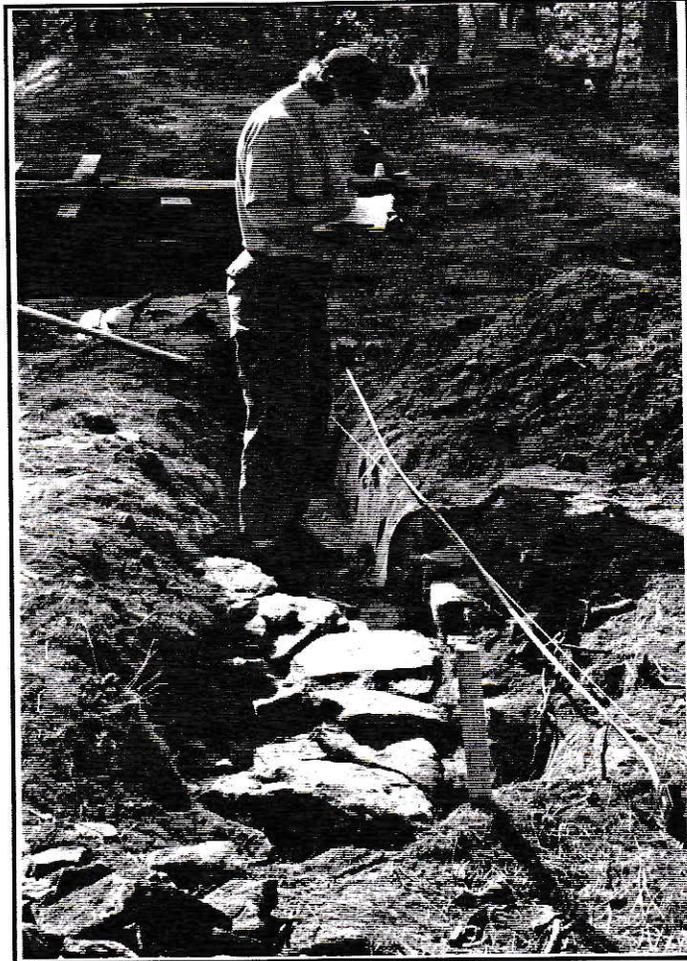
Figure 34. Stacked foundation stones associated with the hunting camp building.

were no longer in alignment; however, a line of partially buried stacked rock that probably is part of the original foundation for the hunt club was identified along the E240 line (Figure 34).

A concentration of limestone rocks (measuring approximately 8 x 10 m) was visible in the center of the fort enclosure where the hunt club building was thought to have stood. A depression was also observable near the stone concentration. Removal of the obscuring vegetation and the excavation of a trench in the depression confirmed that this area had been the location of the hunt club building. The depression yielded mortared brick and concrete that originated from a vaulted roof and cap that covered a cistern. A hand operated pump probably served to transport water for use in the hunt club's kitchen. Most of the exposed foundation stones

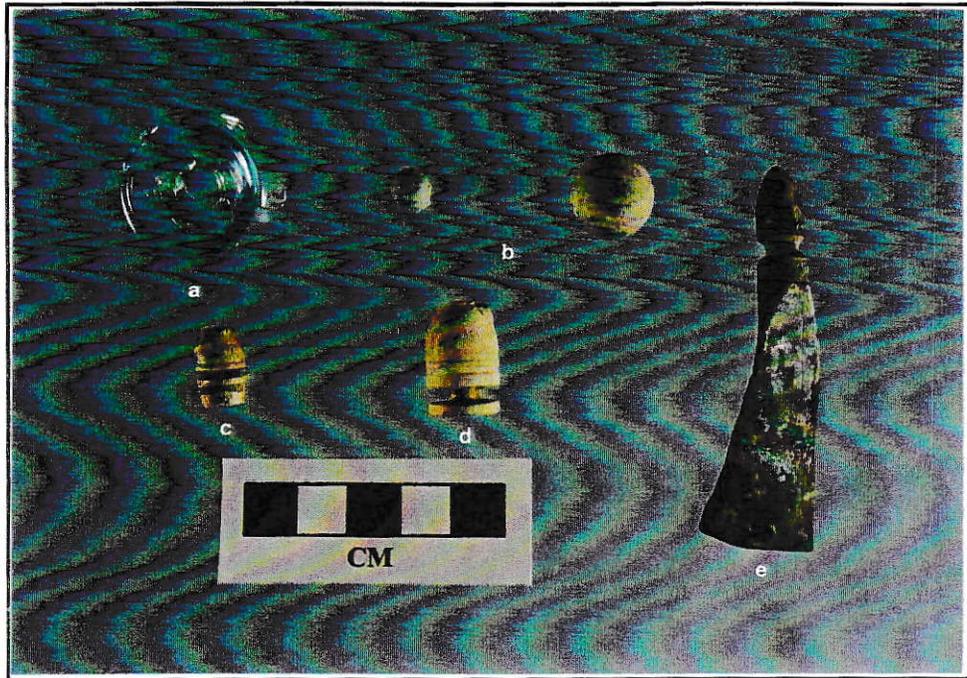
Figure 35. Artifacts dating to the Civil War occupation (a - empontilled bottle; b - buckshot and ball from a buck-and-ball cartridge; c - 40 cal. conical bullet; d - 55 cal. Williams bullet; e - Springfield bayonet scabbard tip).

Artifacts attributed to the arms and military category include ammunition, gun accoutrements, and canteens. Ammunition included three lead balls and one buckshot from "buck and ball" cartridges used in .69 calibre muskets, a .40 calibre lead conical ball, a .50 calibre lead round bullet, and a .58 calibre lead Williams bullet (see Figure 35).

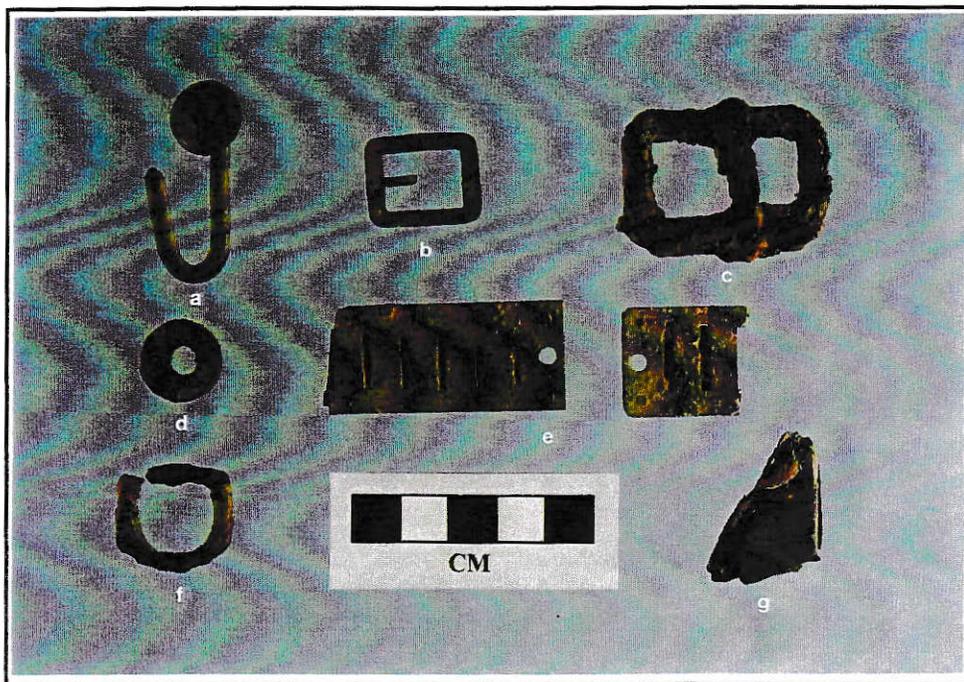
Figure 36. Artifacts dating to the Civil War occupation (a - knapsack hook; b - knapsack buckle; c - cartridge box buckle; d - washer; e - harmonica parts; f - haversack loop; g - unidentified metal tip).
